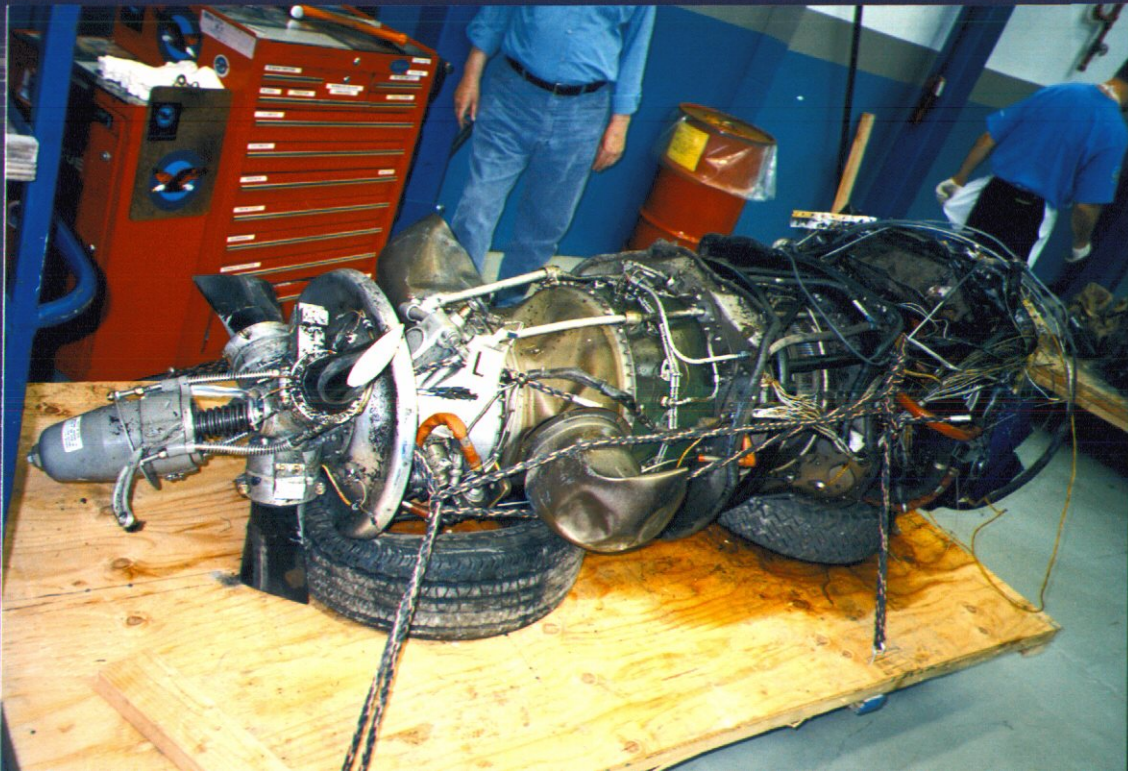
Photo 15: View of left engine as received at engine inspection facility.
